Understanding Potential Induced Degradation for LG NeON Model

1. Introduction

2.1 Potential Induced Degradation

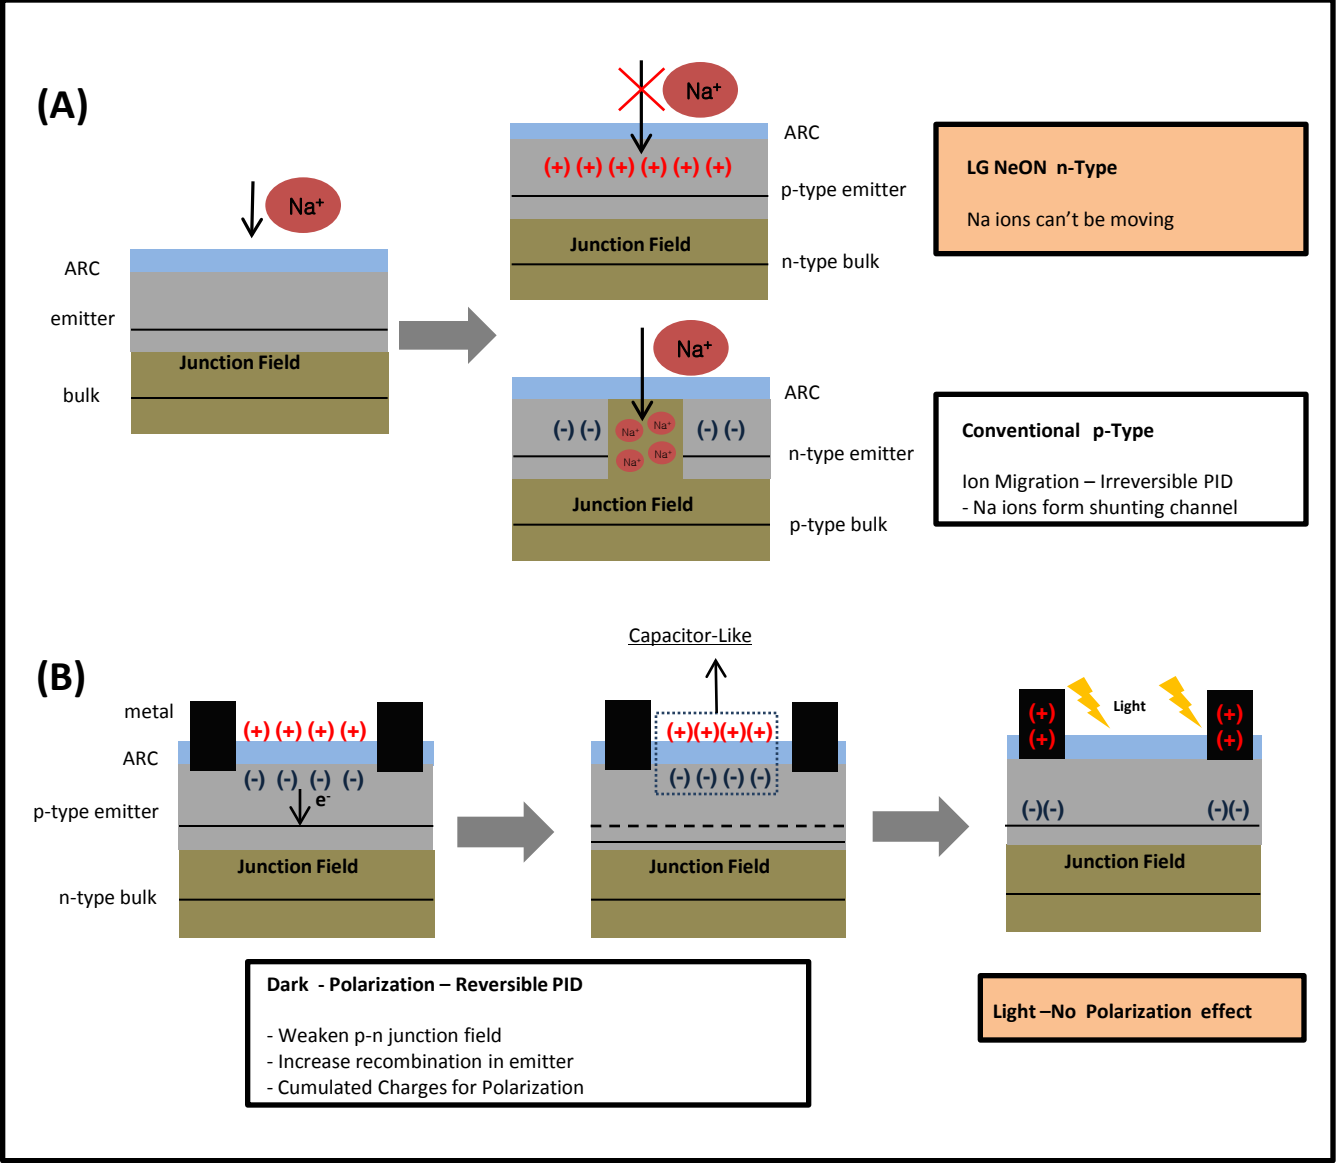
Figure 2 : (A) Electrochemical Corrosion, (B) Polarization Effect

There are two causes for PID to occur in a PV Module: Electrochemical Corrosion and Polarization Effect. (See Figure 2.)

First, Electrochemical Corrosion can be verified with a Corona Discharge Test, in which the cause of PID is not dependent on the type of ion. One prevalent ion found in the glass to cause PID is the sodium ion (Na). Because the Na carries a positive ion (+), the electrochemical Corrosion caused by the Na⁺ ion creates a destructive effect on the P-N Junction of the solar cells, resulting in power degradation of the solar module. This degradation is irreversible.

Second, Polarization cumulates charges around the SiNx ARC and can disrupt the minority carrier movement and the junction electrical field, resulting in the power degradation of the cells.

Generally, the cell itself is consisted of two components: a capacitor and a resistor, that link together in parallel. The capacitor represents the charges accumulated on and around the insulating ARC layer, and the resistor symbolizes conductive channel allowing for the dispersion of charges. To prevent PID behavior, the goal is to prevent charges from building up in the capacitor. [5]

However, the + ion cannot shunt LG n-type cells, which have a p-type emitter on its top surface, as opposed to the n-type emitter that most p-type modules have on their top surfaces. As a result, Electrochemical Corrosion cannot be found on LGE n-type modules.

However, the polarization effect is a reversible reaction, and modules can recover from polarization. The solar cells naturally recover to its normal condition after PID had been occurred, and recovery is accelerated while under high temperature or opposite polarity.

Although LG n-type cells do show the power degradation under normal PID Test condition, they naturally prevent the charge from building up while under irradiance, eliminating any effects from polarization.

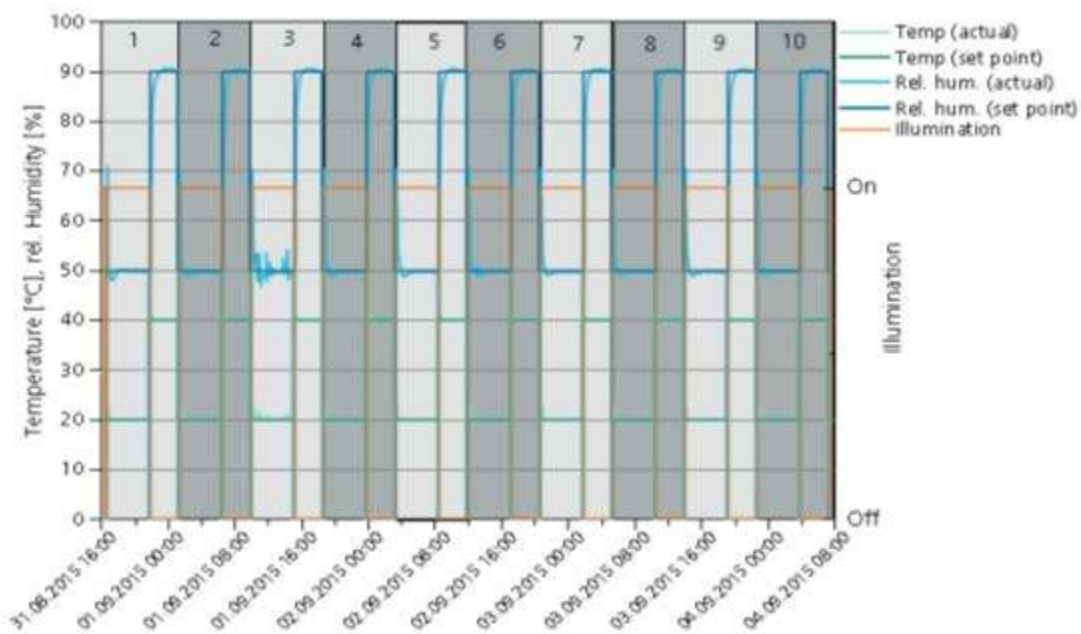
Figure 3 : Climate chamber characteristic – modules M03, M04

During the PID-/ light-recovery sequence, ten cycles of changing ambient conditions are subsequently completed. During the first five hours of each cycle, the front side of the modules is exposed to an illumination of roughly 1000 W/m² at ambient conditions of 20 °C and 50 % relative humidity in the climate chamber (similar to daylight conditions). During the following 3 hours the ambient conditions are set to 40 °C and 90 % relative humidity without illumination (similar to night conditions).

During the ten cycles, a voltage of -1000 V is applied on modules M03 and M04 and +1000 V on modules M05 and M06.

Figure 3 and Figure 4 show the graph of the actual and set ambient conditions in the climate chamber.

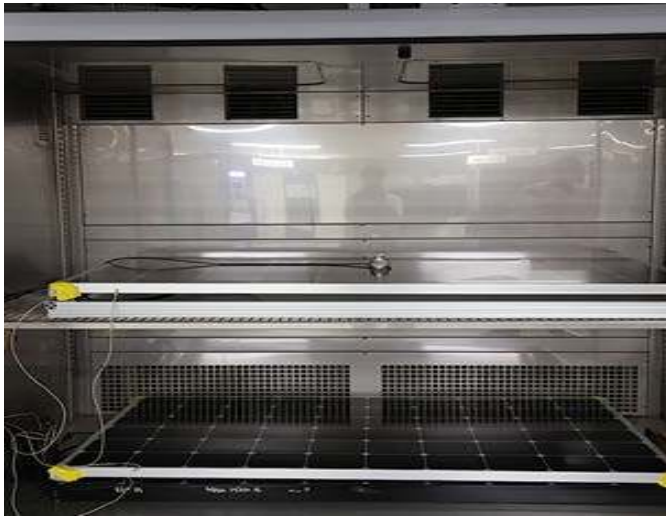
Figure 5: PID Test with Light source

In order to verify PID effect under illumination, Step 1 was tested under a light source. The was tested under irradiance with intensity as high as 1000 W/m² and as lows as 200W/m² to simulate conditions on a fine sunny day and a cloudy day, respectively.

Figure 5 shows PID Test condition with a light source.

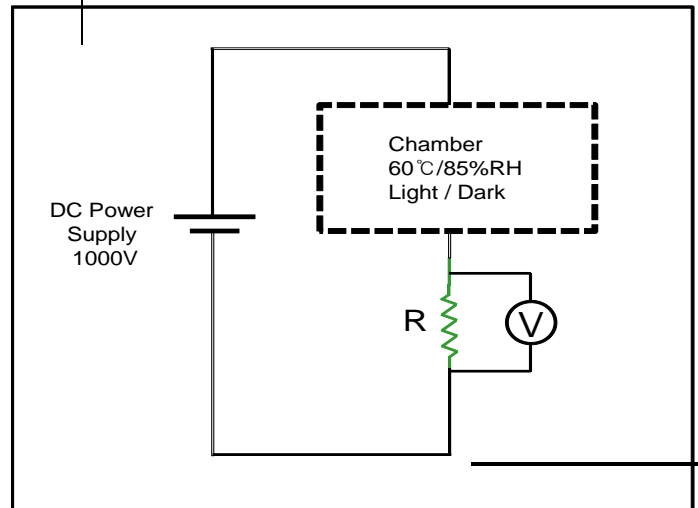
Figure 6: Schematic of leakage current measurement system

Figure 6 shows the scheme of PID test to observe the leakage current. The module is placed in an environmental chamber so as to control module temperature, relative humidity and irradiance. The leakage current is compared in dark and light state, respectively.

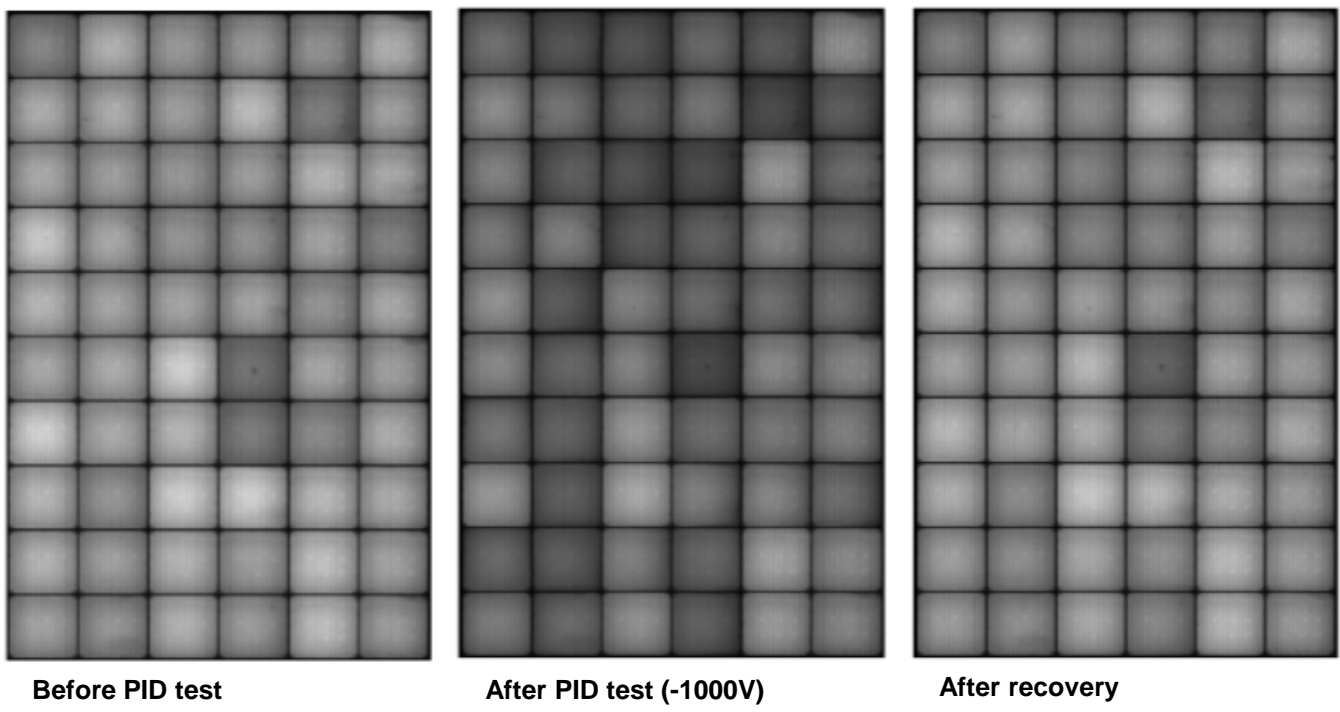
Table 3 : Electroluminescence images of module M03

The PID affected area of a solar cell or even the whole cell appears dark in the image and PID affected cells can be identified. Tables 3 to Table 6 show the EL images of the tested modules before and after the PID test and after the PID-/ light-recovery sequence.

After the first PID test (acc. to IEC TS 62804 ed.1), a negative deviation of output power was recorded for the four modules. While for modules M03 and M04 the power loss was -4.0 % and -2.3 %, for modules M05 and M06 it was only -1.0 % and -0.8 % and therefore nearly negligible. All modules are not rated as sensitive to PID assuming a pass/fail criterion of max. 5 % power loss. However, exposed at negative potential, the power loss is slightly higher than at positive potential, which indicates a slight sensitivity to negative ground potential. The EL images support this impression, as some slightly darker cells can be found on modules M03 and M04 after the first PID stress treatment.

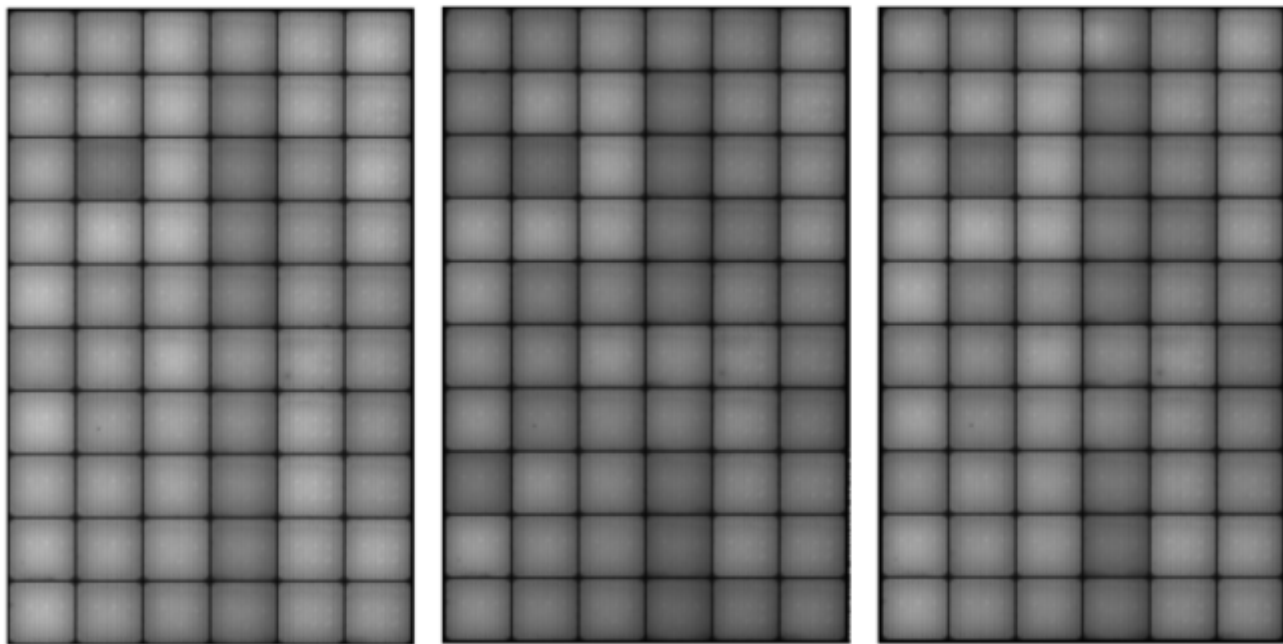
Table 5 : Electroluminescence images of module M05

Before PID test

After PID test (+1000V)

After recovery

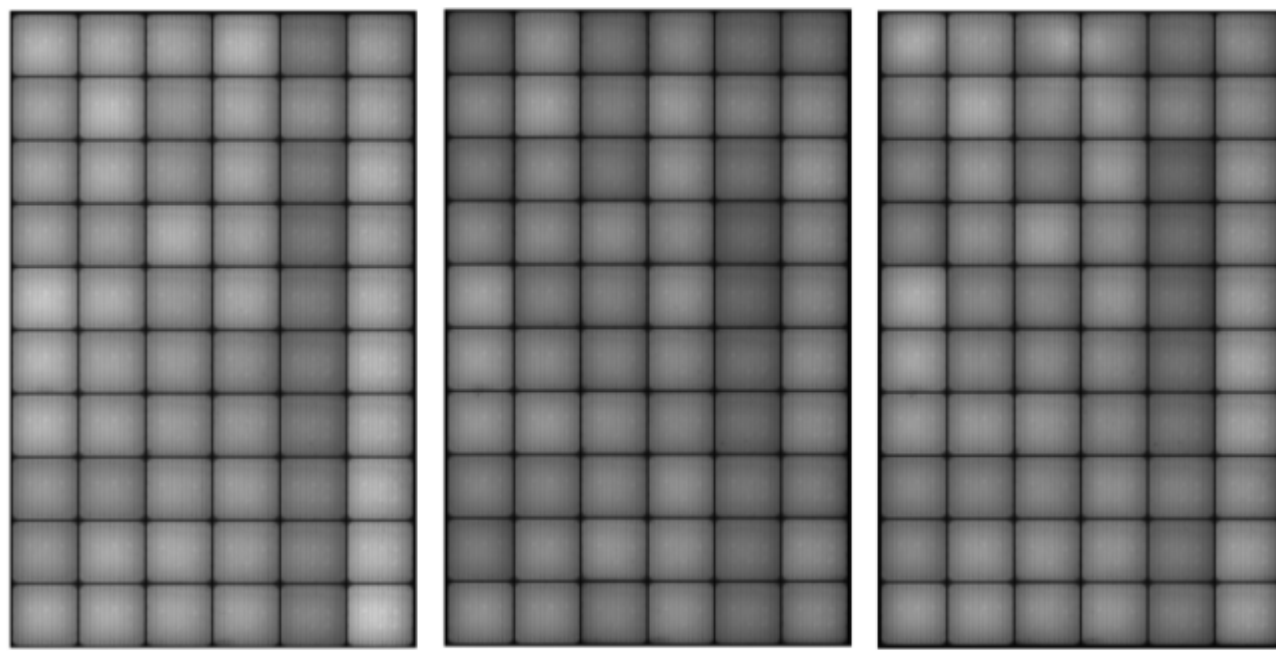
Table 6 : Electroluminescence images of module M06

Before PID test

After PID test (+1000V)

After recovery

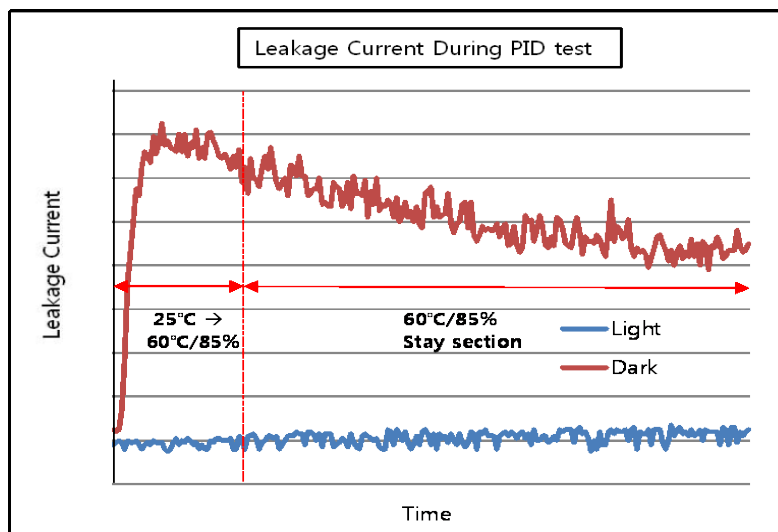
Figure 7: Leakage current comparison (light / dark)

Examining the leakage current during PID test, a current profile of the dark state's module similar to that of a capacitor is observed, on the other hand a current of the light state's module is not observed. (see Figure 7)

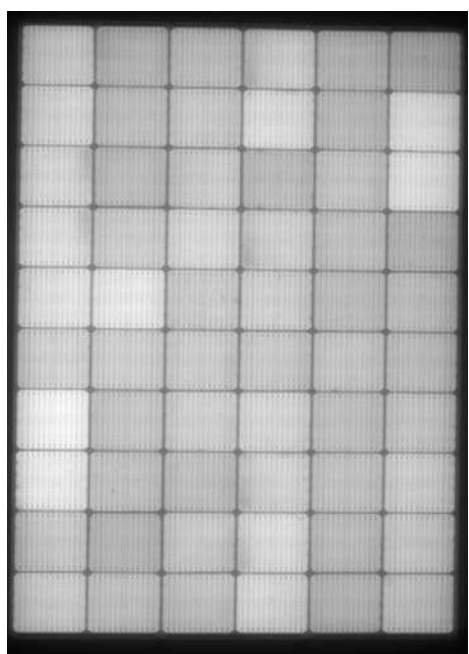
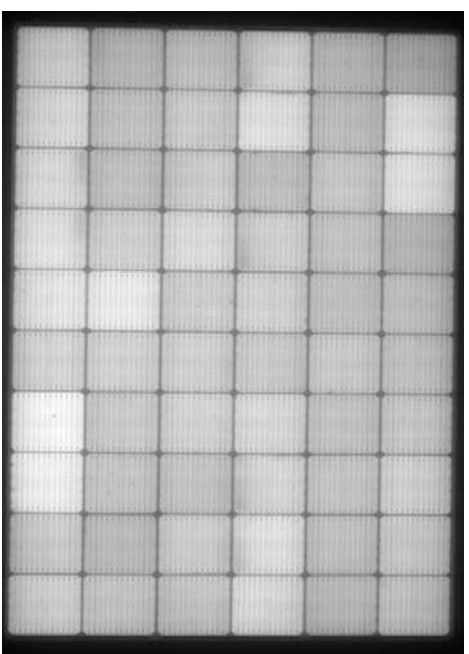
Table 8: Electroluminescence images of module M07

In this chapter, the results of the performance measurements at STC are given. Table 7 list the results of the measurements before and after the PID test. The deviation from the initial measurement is also given. Tables 8 to Table 9 show the EL images of the tested modules before and after the PID test

Before PID test

After PID test (-1000V)

And the second PID test (acc. To IEC 62804 ed.1 with light source), a negative deviation of output power was recorded for the two modules. While for modules M07 and M08 it was only 0.02% and -0.61%.

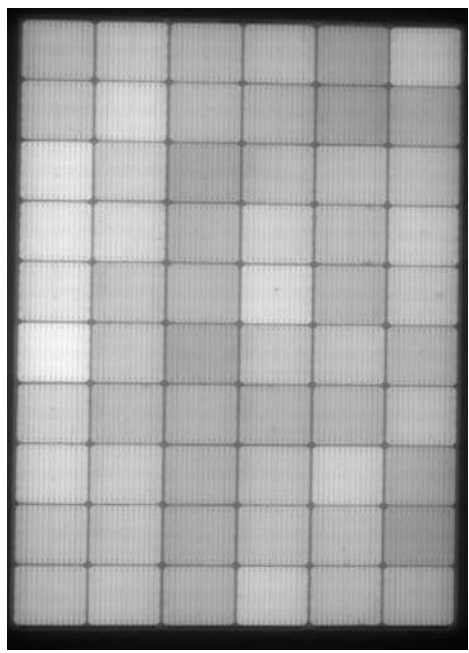
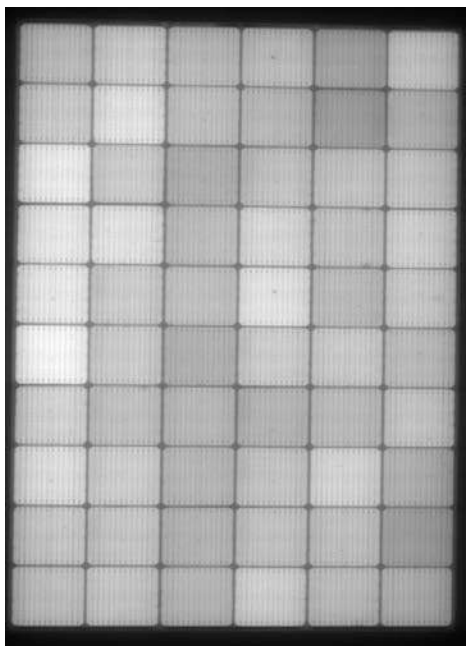
Table 9: Electroluminescence images of module M08

Before PID test

After PID test (-1000V)
