Isolation Fault Troubleshooting - Application Note

This document describes how to identify and locate an isolation fault in a SolarEdge system.

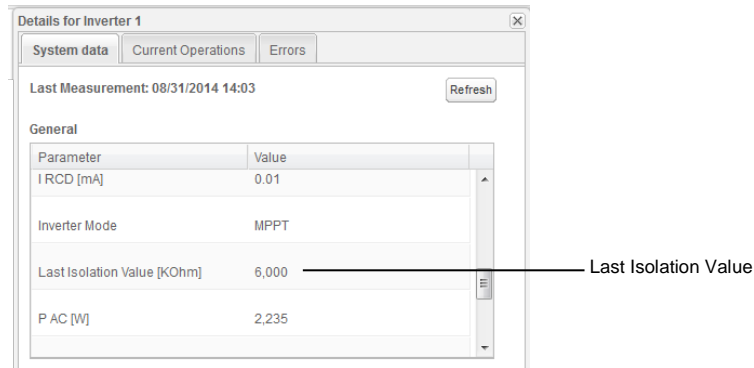
Figure 1: System data tab in the Details window

- 1 In the **Layout** window right-click on the inverter and select **Choose operations** → **Reset**.
- 2 Right-click on the inverter and select **Info** to display information about the inverter.
- 3 In the **General** parameter list, check the **Last Isolation Value**.
