Isolation Fault Troubleshooting - Application Note

This document describes how to identify and locate an isolation fault in a SolarEdge system.

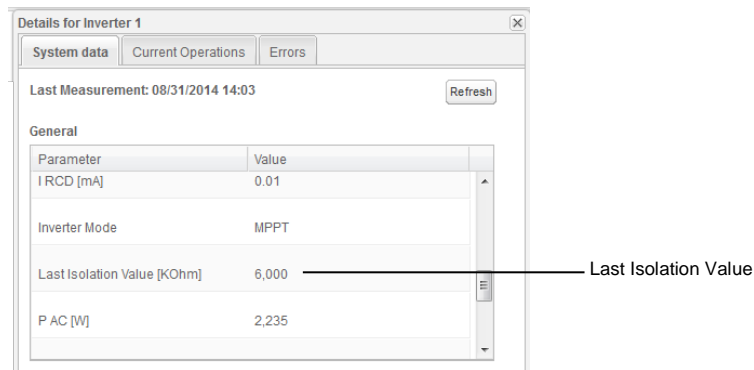
Figure 1: System data tab in the Details window

► **To check the isolation value in the monitoring portal:**

- 1 In the **Layout** window right-click on the inverter and select **Choose operations** → **Reset**.
- 2 Right-click on the inverter and select **Info** to display information about the inverter.
- 3 In the **General** parameter list, check the **Last Isolation Value**.

An isolation fault may disappear and recur after a short period (especially if it is caused by morning moisture), therefore it is recommended to troubleshoot the fault as soon as it occurs, before it may temporarily disappear. Before troubleshooting on site, you may check the isolation value in the SolarEdge monitoring portal. If the value is borderline (within 10%) or below the limit (600kΩ for single phase inverters / 1MΩ for three phase inverters), troubleshoot the fault on site. If the value is at least 10% higher than the limit, it is better to wait until an isolation fault error recurs.

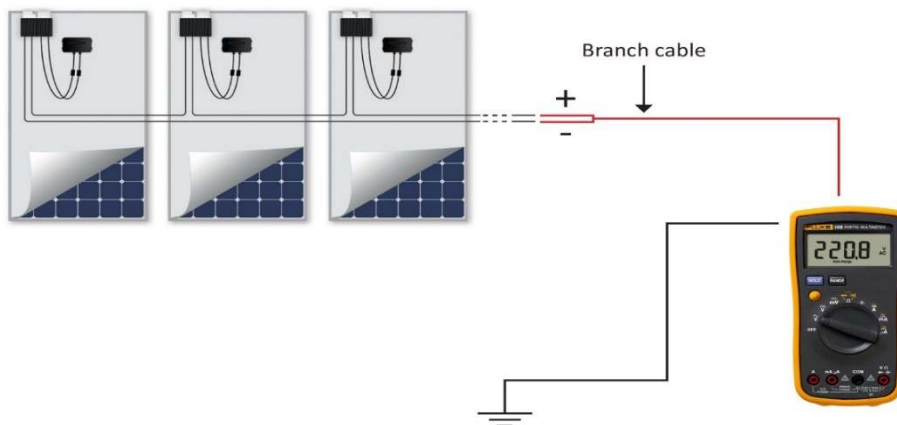
Figure 2: Connecting the insulation tester to the PV string

- 4** Test the *string resistance* using the insulation tester (see Figure 2):
 - a. Verify safe string voltage and current: max. 50V and 500mA.
 - b. Connect the positive and negative connectors of the first or last optimizer in the string to the branch cable.

- c. Connect the positive probe of the insulation tester to the branch cable.
 - d. Connect the negative probe of the insulation tester to a ground point.

- e. Select 500V testing on the insulation tester, or 1000V if required (e.g. to comply with NEN-EN-IEC 62446).
 - f. Test the insulation.

If the resistance is less than 600kΩ in a single phase inverter or less than 1MΩ in a three phase inverter, continue checking this string’s components to isolate the source of leakage, as detailed in the following steps. Always make sure to connect both negative and positive output connectors to the tester using a branch cable.

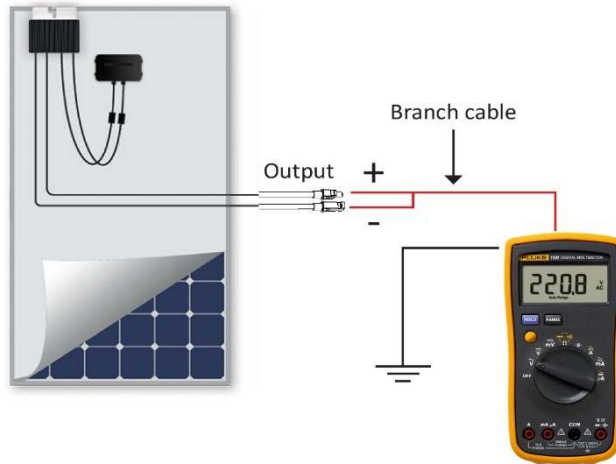
Figure 3: Connecting the insulation tester to the power optimizer and module

- 5** Test the *power optimizers’ and modules’* resistance using the insulation tester (see Figure 3):
 - a. Disconnect the power optimizer from the string; it should remain connected to the PV module.
 - b. Verify safe power optimizer voltage and current: max. 1V and 500mA.

- c. Connect the power optimizer's positive and negative *output* connectors to the branch cable.

- d. Connect the positive probe of the insulation tester to the branch cable.
- e. Connect the negative probe of the insulation tester to a ground point.
- f. Select 500V testing on the insulation tester, or 1000V if required (e.g. to comply with NEN-EN-IEC 62446). If the measured resistance is 200MΩ or more, the power optimizer and module are not faulty. If the measured value is less than 200MΩ, the optimizer, the module or both are faulty. Continue checking as detailed in the following steps.

Connecting the insulation tester to just one of the power optimizer connectors or to just one of the DC cables may cause irreversible damage to the power optimizer.

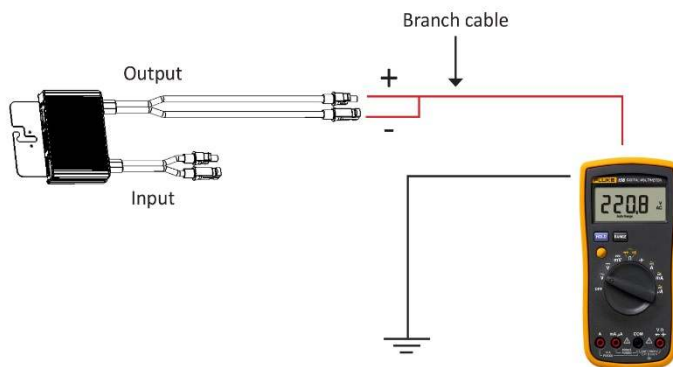
Figure 4: Connecting the insulation tester to the power optimizer

- 6 Find whether the leakage is from the module or from the power optimizer. Test each component individually by measuring the resistance between negative wires and ground:
 - a. Disconnect the module from the power optimizer.
 - b. Connect the power optimizer's positive and negative *output* connectors to the branch cable (see Figure 4).
 - c. Connect the positive probe of the insulation tester to the branch cable.
 - d. Connect the negative probe of the insulation tester to the power optimizer frame (ground point).
 - e. Select 500V testing on the insulation tester, or 1000V if required (e.g. to comply with NEN-EN-IEC 62446).
 - f. Measure the resistance; if the value is 200MΩ or more – the module is faulty; if the value is less than 200MΩ, replace the optimizer and test the module in case it is faulty as well.

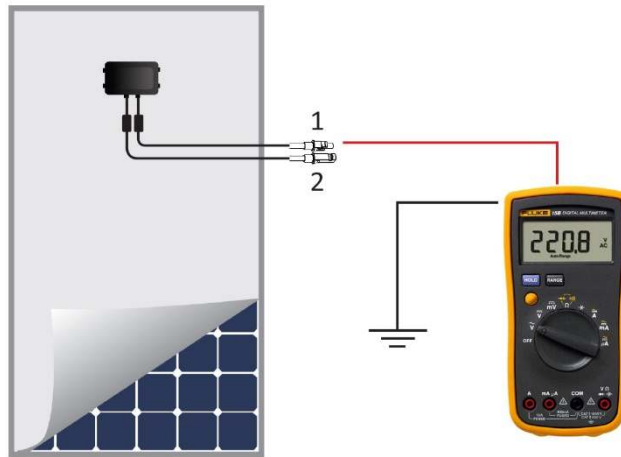
Figure 5: Connecting the insulation tester to the module

- g. Disconnect the branch cable from the power optimizer.
- h. Connect the one of the module's input cables to the positive probe of the insulation tester and connect the negative probe of the insulation tester to a ground point (see Figure 5).
- i. Measure the output resistance, if the value is less than 500MΩ, the module is faulty. If the value is 500MΩ or more, repeat for the other input cable. If the value is less than 500MΩ, the module is faulty; if the value is 500MΩ or more – the module is OK.
